Inspection Report

225 Pinewood Ln #C16
Ketchum ID 83340

Sun Valley Home Inspections

Date: 11/10/2023	Time: 01:30 PM	Report ID: 20231110-225-Pinewood-Ln-C16
Property: 225 Pinewood Ln #C16 Ketchum ID 83340	Customer: Buck Drew	Real Estate Professional: Scott Mary

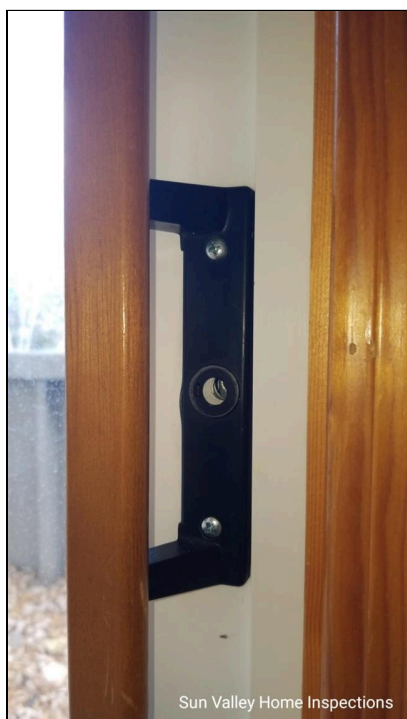
1.0

🔧 **1.0** Latch for the master bedroom exterior door was missing at the time of the inspection preventing the door from securely locking.

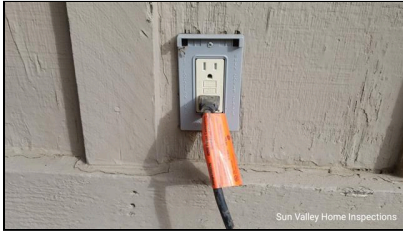
1.3

**1.3** Weatherproof cover at an exterior receptacle was damaged at the time of the inspection.

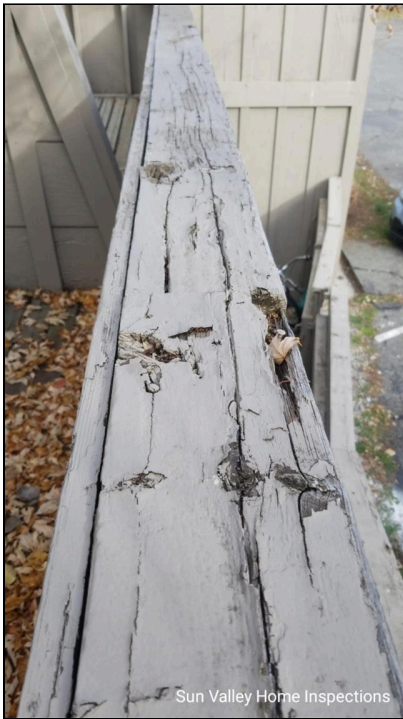
1.4

**1.4** The top cap of the deck guardrails had moderate to significant wood decay.

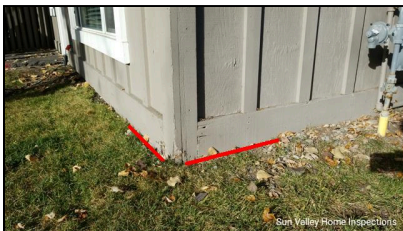
1.7

**1.7** Wood siding covering exterior walls had damage visible. This condition appeared to be the result of wood decay caused by moisture absorption due to inadequate clearance from grade. Wood siding should have a minimum clearance of 6 inches from grade.

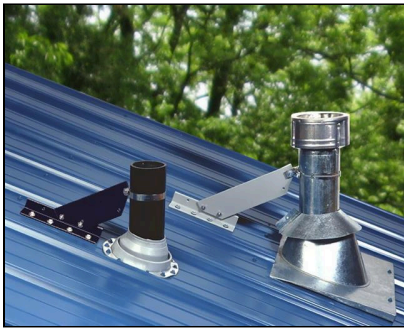
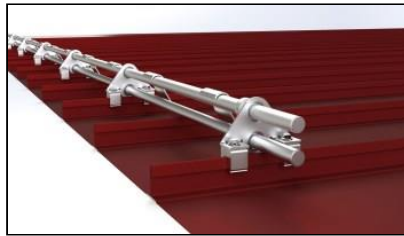
2.6 (1) Snow guards/brakes are recommended along the eaves of the roof. These may help to prevent snow/ice from sliding off of the roof and causing physical harm to occupants and/or physical damage to areas of the roof and items below the roof. Consult with a qualified roofing contractor about the options available and what may work best for this home.

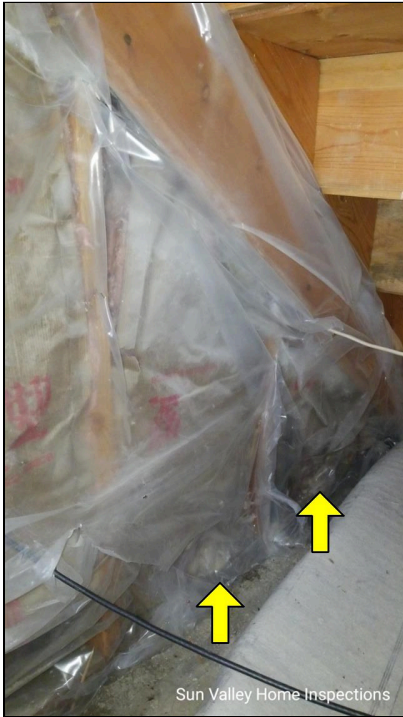
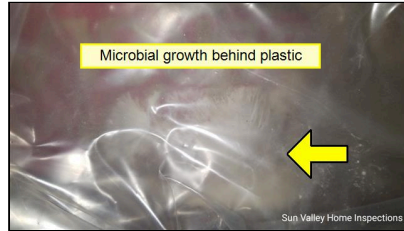
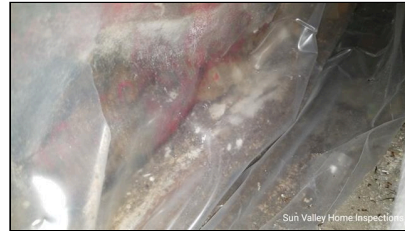
3.4 The under stairway closet had limited areas of potential minor wood decay and discoloration that appeared to be microbial growth. Confirming the presence of mold would require laboratory analysis. To avoid potential damage to home materials or the development of unhealthy conditions related to mold, the Inspector recommends that the source(s) of potential moisture be identified and the condition corrected.

This is likely the result of water intrusion occurring at the sill plate and siding along the lower edge of the South exterior wall.

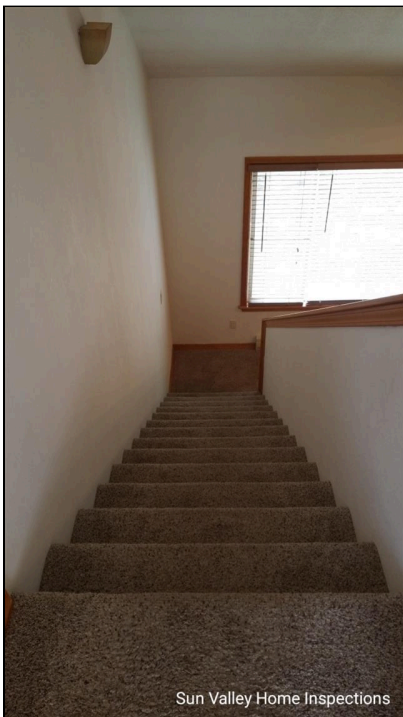
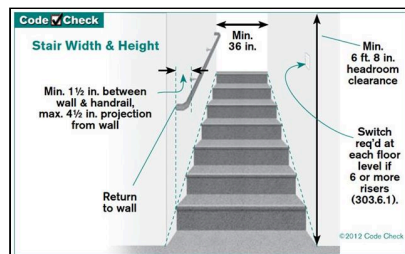
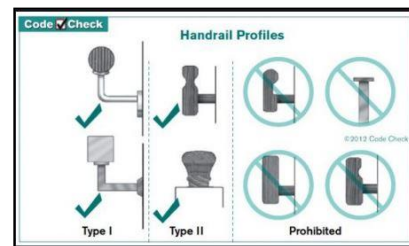
4.6

Consider having a graspable handrail installed to make it compliant with modern safety standards:

- 1: Measure 1¼ inches to 2 inches across (if circular)
- 2: Be 34 inches to 38 inches above the nosing of stair treads
- 3: Be continuous for the full length of the flight of stairs
- 4: Return to the wall at the top and bottom or terminate at a newel post
- 5: Be a minimum of 1½ inches from the wall
- 6: Have a graspable profile

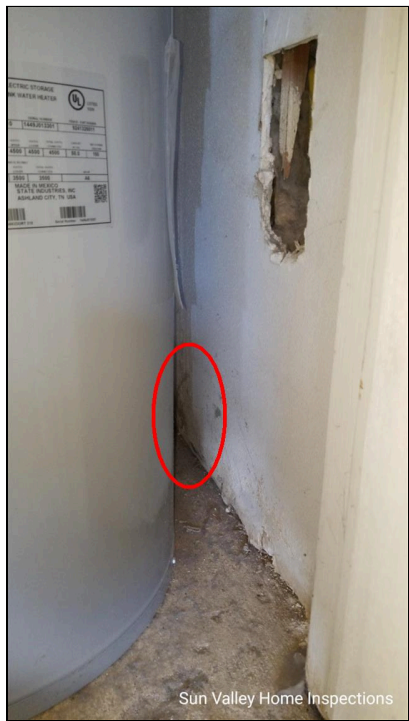
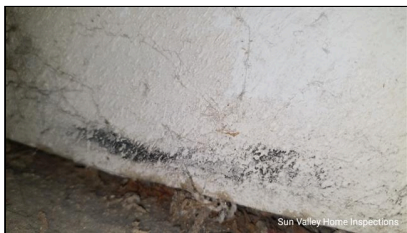
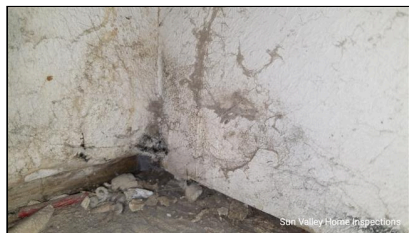
4.7

**4.7** The Inspector observed what appeared to be microbial growth in the 2nd bedroom next to the water heater. Identifying mold requires laboratory testing. When exposed to moisture levels at or above approximately 27% in materials, mold can produce airborne spores. High concentrations of spores can represent a health hazard to those with asthma, allergies, lung disease, or compromised immune systems. At moisture levels below about 27%, mold fungi do not produce spores. Small amounts of mold can be removed with detergent and a brush and the area treated with a fungicide. Large amounts are typically removed with abrasive materials or encapsulated, depending on the location. The inspector did not observe any signs of elevated moisture content in this area. The source may have been corrected, or the source may be seasonal.

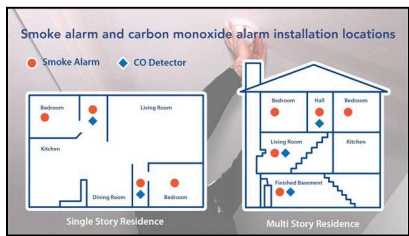
4.9

**4.9** No visible Carbon Monoxide detectors were identified in the home. The inspector always recommends installing Carbon Monoxide detectors in a home that has a: gas water heater, furnace, wood/gas fireplace and any fuel-burning appliance. Refer to the installation instructions provided with the CO detector about correct placement.

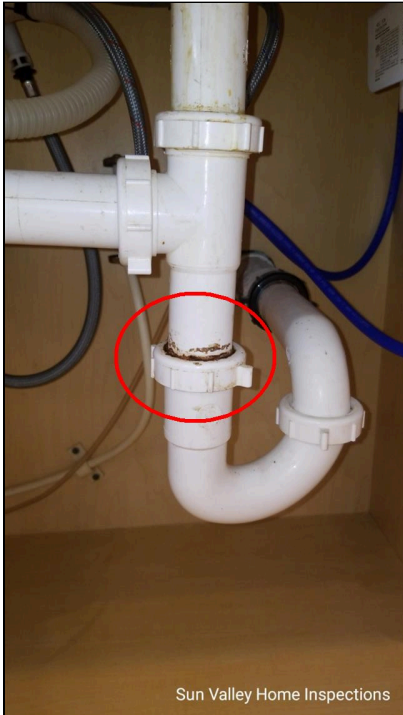
5.3 The drain/waste line for the kitchen sink was leaking at the time of the inspection. Repairs are needed. I recommend a qualified licensed plumber repair or correct as needed.

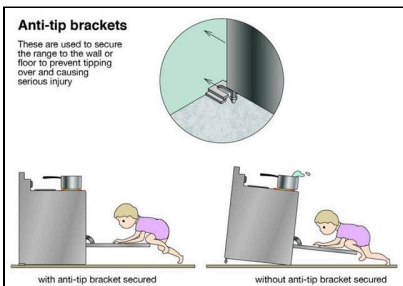
5.6 The range did not have an anti-tip device installed. This bracket is essential to the safe operation of the range. It provides protection when excess force or weight is applied to an open oven door such as a child standing on the open oven door. The Inspector recommends installation of an approved anti-tip device. Most manufacturers will send you an anti-tip device free of charge.

5.6 Anti-tip Bracket

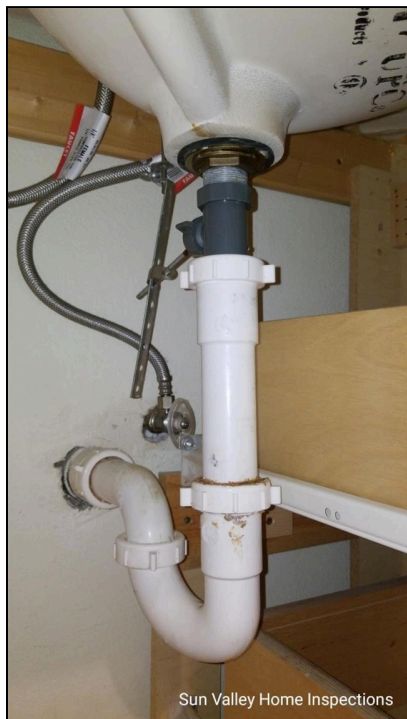
6.4 (1) In the master bathroom, leaking connection at the sink drain beneath the sink should be repaired to avoid future/additional damage to the cabinet floor and possibly the wall/floor structures below.

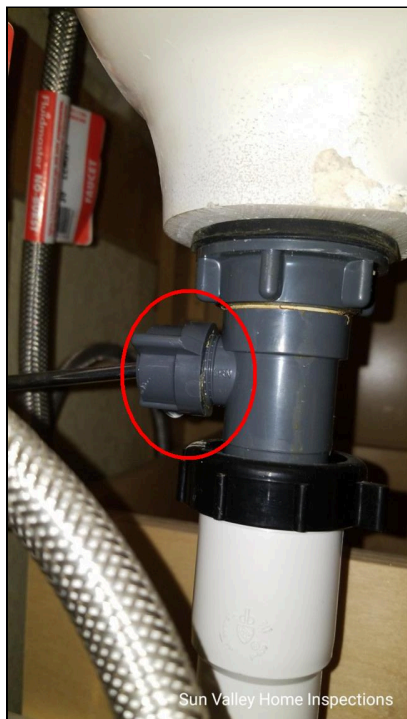
6.4 (2) In the 2nd bathroom, leaking connection at the sink drain beneath the sink should be repaired to avoid future/additional damage to the cabinet floor and possibly the wall/floor structures below.

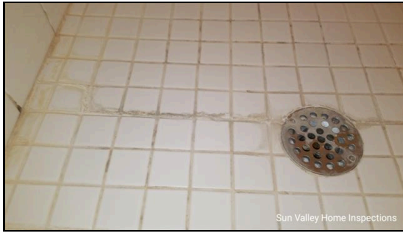
6.7

**6.7** (1) Mineral buildup between the tile grout in the master bathroom indicates that water may be getting below the tiles.

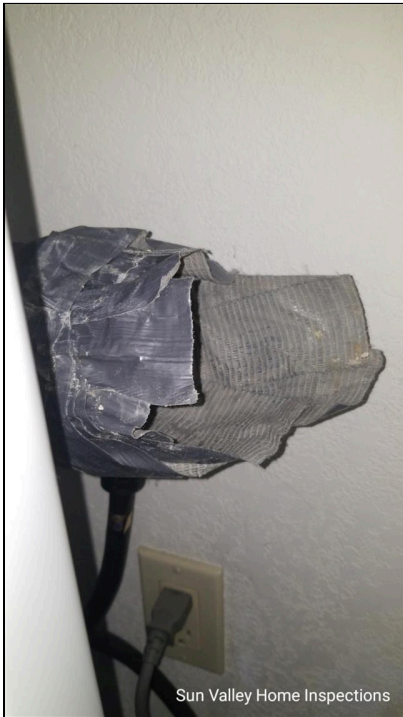
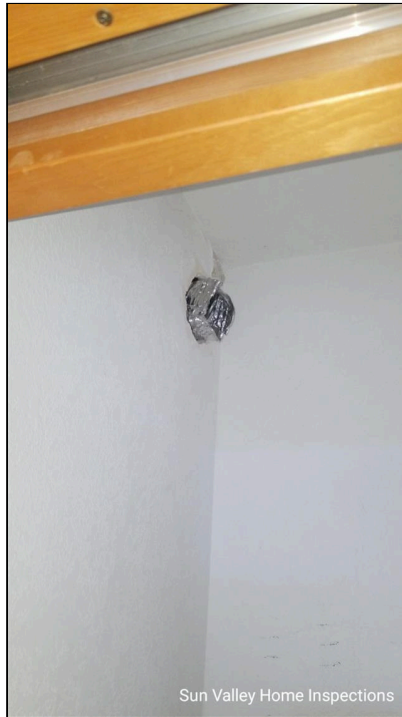
7.1

🔧 (2) The dryer vent was disconnected behind the dryer and should be reconnected to properly route to dryer exhaust to the exterior. Failure to reconnect the vent may result in unsatisfactory condition from excessive humidity and lint accumulation in the home. Excessively high humidity can damage home materials or components and may encourage the growth of microbes such as mold.

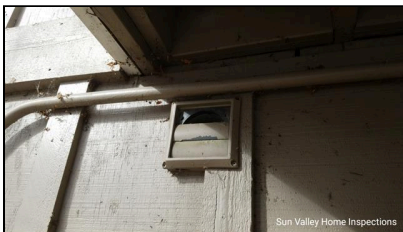
7.1

🔧 (3) The exterior duct hood/damper of the dryer vent was damaged at the time of the inspection. Replacement is recommended.

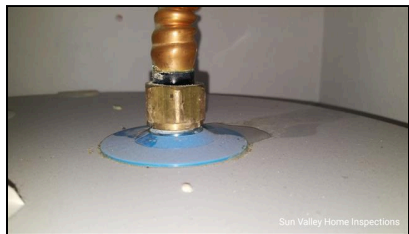
9.3 Actively leaking water visible at the noted cold water pipe/connection of the water heater at the time of the inspection.

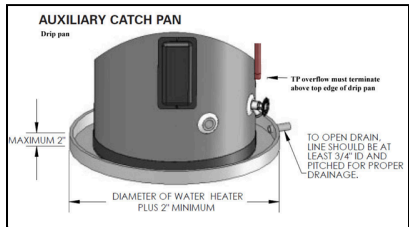
9.6 Although this water heater was installed in a location in which leakage of the tank or plumbing connections would cause damage, no drip pan was installed. A proper drip pan is recommended to be installed by a qualified plumbing contractor to prevent possible water damage.

9.6 Drain pan

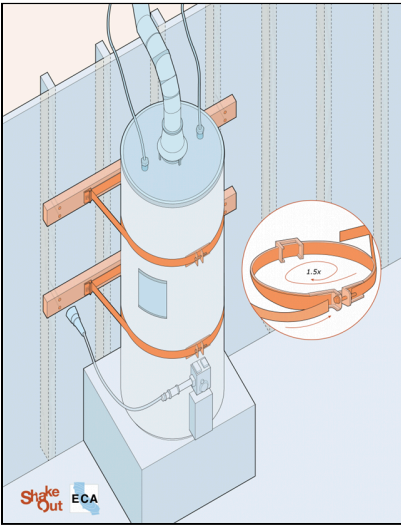
9.7 Water heater lacks seismic straps. Consider installation of this safety feature per modern building standards by qualified contractor. During past earthquakes, water heaters have moved or tipped over if they were not securely anchored to adjacent walls or floors. This movement has resulted in gas line or water line leaks, and electrical wiring damage. Gas line leaks and damaged electrical wiring pose health and fire hazards, and water line leaks can cause significant and costly property damage.

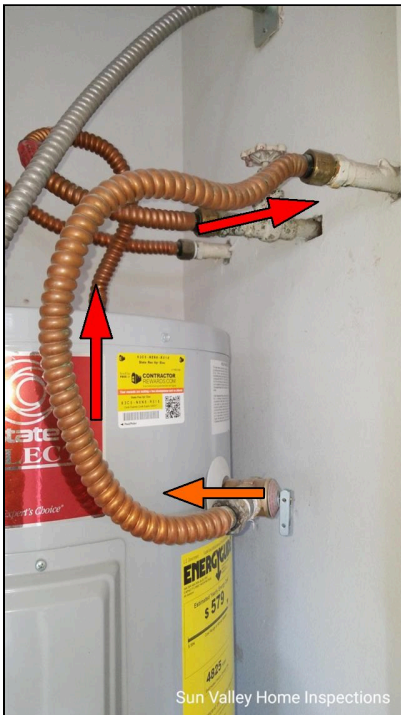
9.8 The discharge pipe of this water heater temperature/pressure relief (TPR) valve was installed so that it does not allow for the natural flow from gravity to drain any discharged water. The Inspector recommends correction by a qualified contractor. *The TPR valve on water heater needs a 3/4 threaded pipe to drain by gravity and extend within 6 inches of the floor for safety. A properly installed TPR valve and discharge pipe allows hot water to discharge through the device when conditions of excessive pressure, excessive temperature or both occur, and directs the water to a safer location (the floor).*

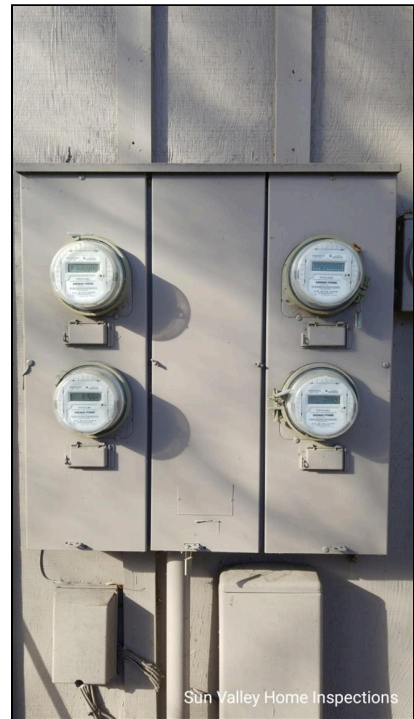
10.1

**10.1** No labeling was provided at the electric meters and service disconnects for this building. Accurate labeling should be provided so that the correct Service Disconnect of the home can be identified in an emergency. Consult with the HOA about adding accurate labels to the meters and disconnects.

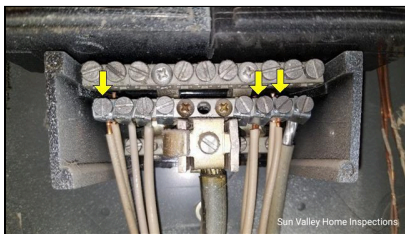
10.4 Several connection lugs on the neutral bus bar were double lugged. Double lugging is where two neutral conductors are connected in the same lug and is an incorrect installation. Each neutral conductor should be under its own connection lug. Although it was generally accepted around the time of the home's original construction, it is recommended that it be corrected to today's safety standards.

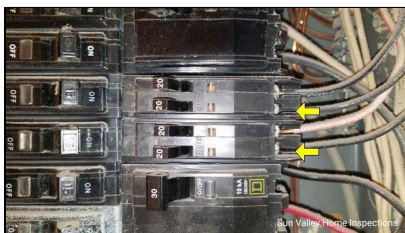
10.5 (1) In the Distribution Panel, several branch conductors were connected to a circuit breaker for which the wire size was undersized and insufficient. This defective condition should be corrected by a qualified electrical contractor.

10.5 Lower of each tandem breaker

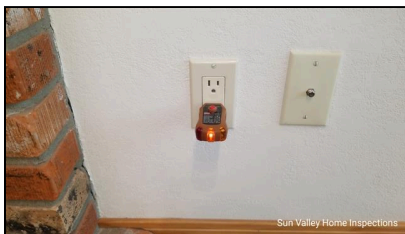
10.6 An electrical receptacle in the family room had an open ground. Other receptacles in the home were grounded. This condition should be corrected by qualified electrical contractor.

10.6 Next to fireplace
