Project: 113 Angani Way

Microbial Investigation

113 Angani Way #2091
Sun Valley, ID, 83353
8/20/24

Clearance Report

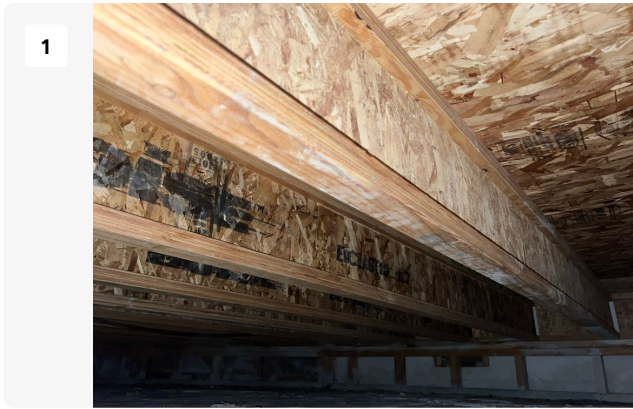
Treated joists and subfloor.

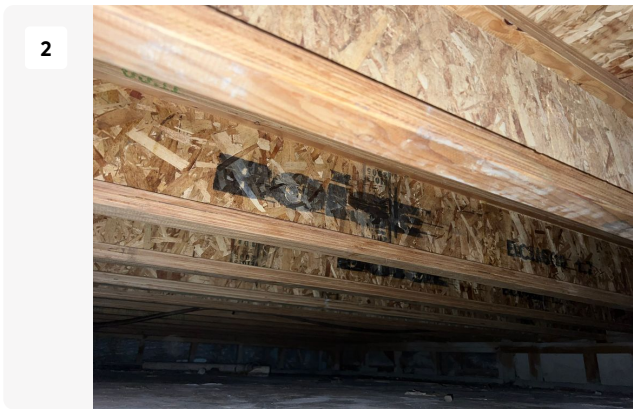
Treated joists and subfloor.

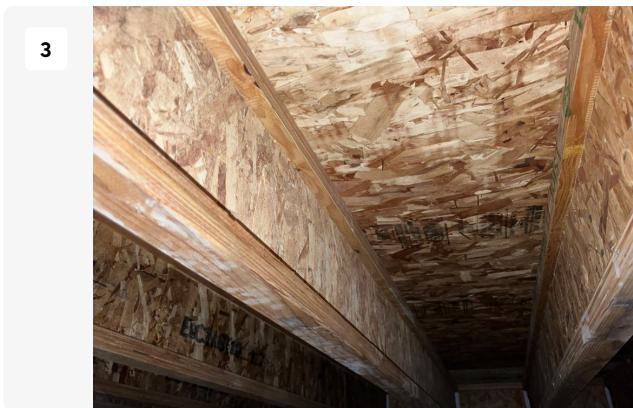
Treated joists and subfloor.

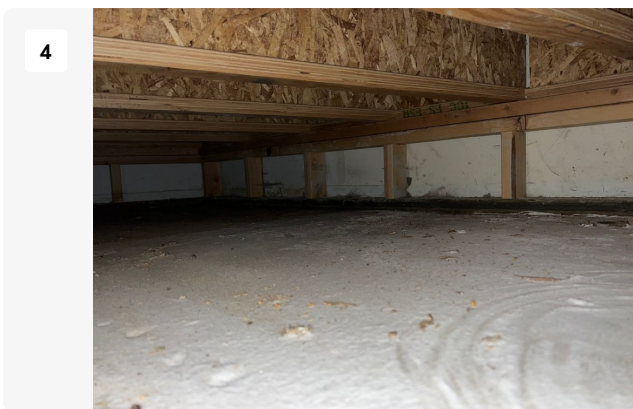
Treated crawlspace.
