Inspection Report

Property Address:
113 Angani Way #2091
Building III
Sun Valley ID 83353

Sun Valley Home Inspections

Date: 5/8/2024	Time: 11:30 AM	Report ID: 20240508-113-Angani-Way-2091
Property: 113 Angani Way #2091 Building III Sun Valley ID 83353	Customer: Courtney Noble	Real Estate Professional: Anna Mathieu

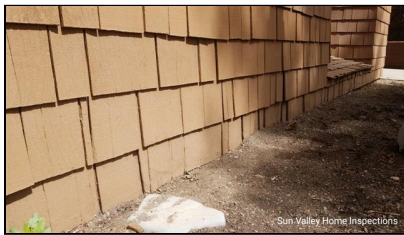
1.6 Wood siding covering exterior walls had damage visible. This condition appeared to be the result of wood decay caused by moisture absorption due to inadequate clearance from grade. Wood siding should have a minimum clearance of 6 inches from grade.

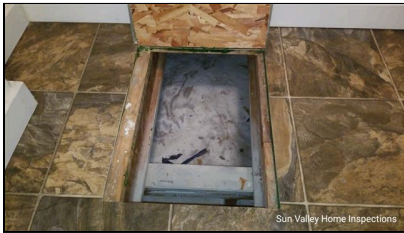
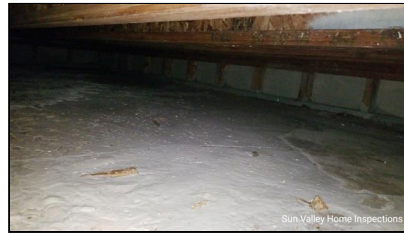
2.0 Crawlspace conditions that in the Inspector's opinion posed a personal safety hazard limited examination of the crawlspace to only those home systems and their components visible from the access hatch. Some areas of the crawlspace were not visible from the access hatch. The Inspector disclaims defective conditions in all areas not visible in the crawlspace from the access hatch at the time of the inspection and that are not listed in the area of this report pertaining to crawlspace conditions. The inspector recommends that

inspection of the entire crawlspace by a qualified inspector be performed after conditions that provide reasonable, safe access to the entire crawlspace exist. Conditions which may limit access include but are not limited to any of the following:

- Less than 24 inches of headroom and restricted access opening size;
- Excessive moisture in soil or on the floor;
- Unsafe structural conditions.
- Suspected biological contamination of the crawlspace;
- Suspected chemical contamination of the crawlspace;
- Presence of pests (insects, reptiles, mammals); and
- Hazardous electrical conditions. The point at which conditions represent a safety hazard is decided upon solely by the Inspector, entry or refusal of entry being completely at the Inspector's discretion.

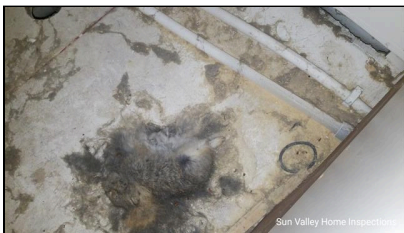
2.5 Signs of previous animal activity was present. Active infestation was not found to the best of my ability at the time of the inspection. Monitor for any new infestation and treat as necessary.

This was evidenced by:

- Rabbit carcass

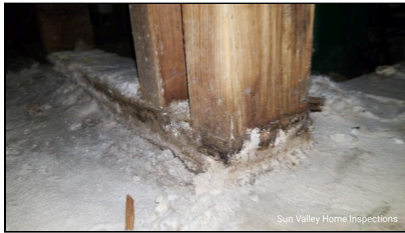
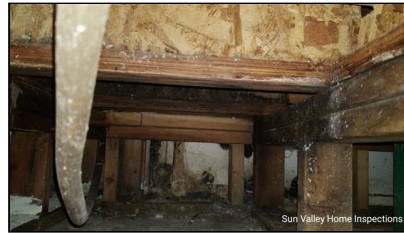
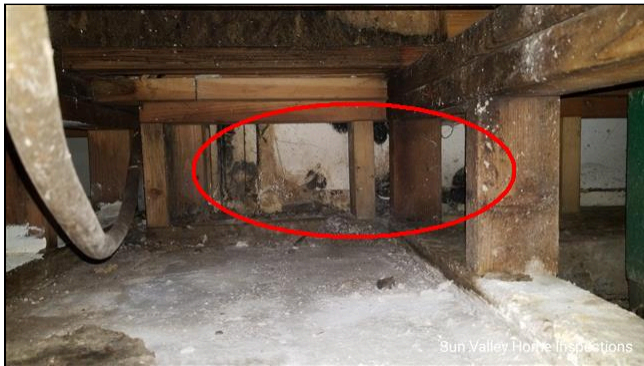
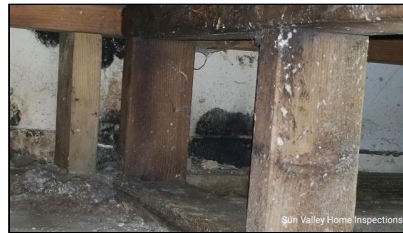
2.6 The crawlspace had limited areas of discoloration that appeared to be microbial growth. Confirming the presence of mold would require laboratory analysis. To avoid potential damage to home materials or the development of unhealthy conditions related to mold, the Inspector recommends that the source(s) of potential moisture be identified and the condition corrected.

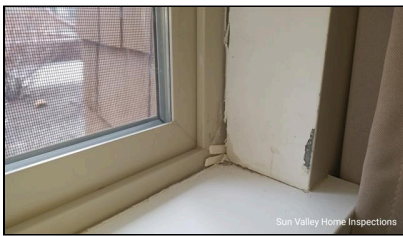
3.4

🔧 (2) Window in the bedroom was slightly loose at the lower right corner and should be resealed to prevent air leakage.

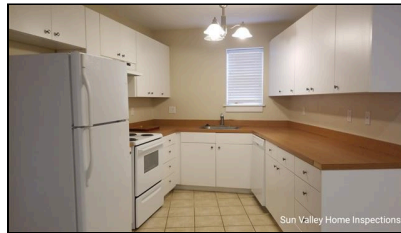
IN	NI	MD	RR	NP
4.0	Electrical Receptacles, Kitchen	•				
4.1	Counters and Backsplash			•		
4.2	Cabinets	•				
4.3	Plumbing Drain and Vent Systems	•				
4.4	Plumbing Water Supply, Faucets and Fixtures	•				
4.5	Dishwasher			•		
4.6	Range/Oven				•	
4.7	Range Hood, Cooktop Exhaust	•				
4.8	Garbage Disposal	•				
4.9	Refrigerator	•

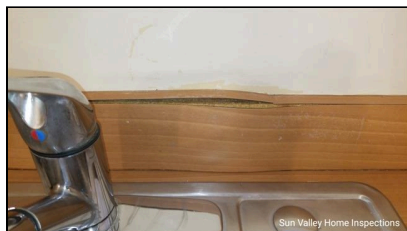
(2) Counter backsplash in the kitchen had moderate water damage visible.

4.1 (1) Maintenance Tip: Caulk all open seams along the backsplash and along the sink to prevent moisture intrusion

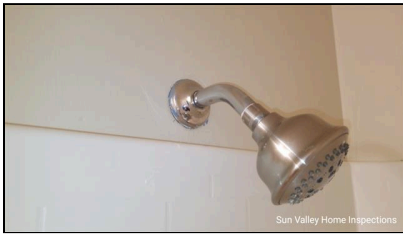
5.7

**5.7** (1) Neck for the showerhead was loosely secured inside of the wall.

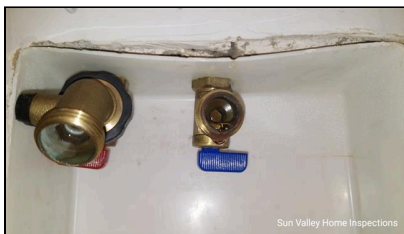
6.3 Both water shut-off valves for the clothes washer were actively leaking slightly at the time of the inspection.

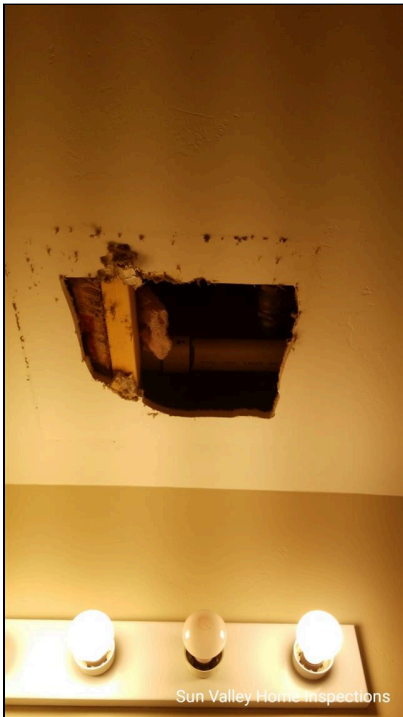
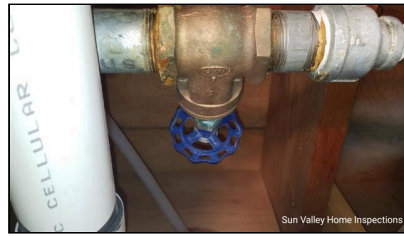
7.1 The main water supply shut-off valve was located in the bathroom ceiling.

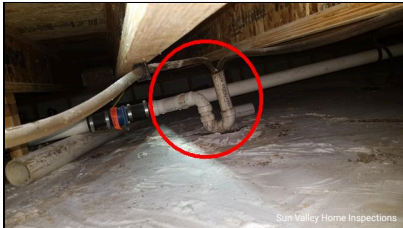
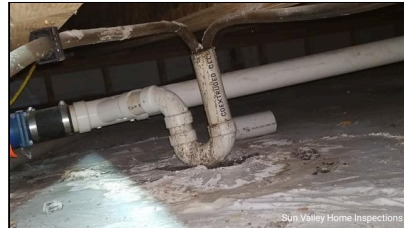
7.2 Drain pipe in the crawlspace had signs of past water leakage and potential recent leakage. Recommend evaluation by a qualified plumbing contractor.

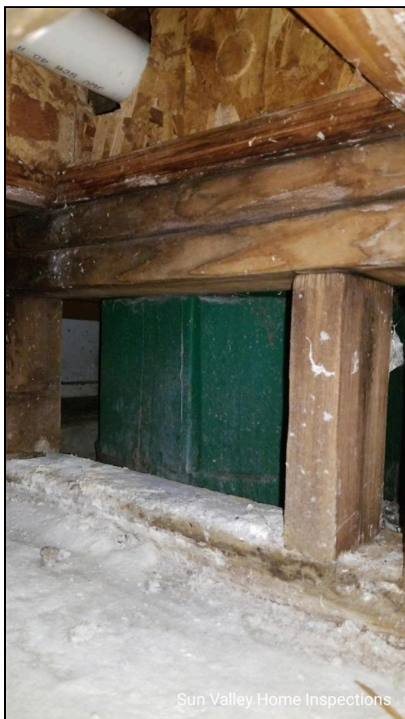
7.4 The area around the sewage ejector pump had a strong odor, indicating that sewer gas is leaking into the crawlspace. This condition should be corrected by a qualified contractor.

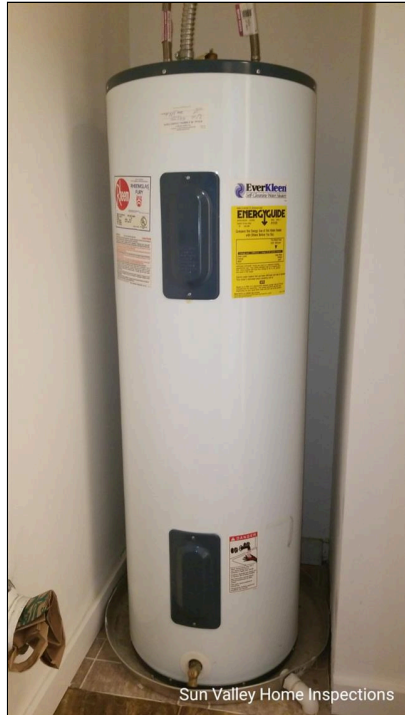
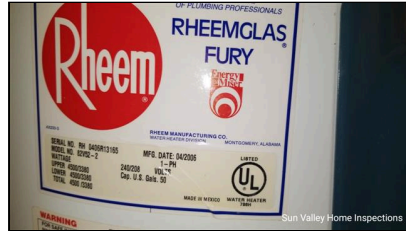
IN	NI	MD	RR	NP	Styles & Materials
8.0	Electric Water Heater	•					Water Heater Brand: RHEEM
8.1	Manufactured Date	•					Water Heater
8.2	Tank	•					Location: Laundry closet
8.3	Plumbing Pipes, Valves (inlet, outlet)	•					Water Heater Power
8.4	Hot Water Distribution (at each plumbing fixture)	•					Source: Electric
8.5	Electrical Wiring	•					Water Heater
8.6	Tank Pan				•		Capacity: 50 Gallon
8.7	Tank Seismic Strap(s)				•	•	Number of Water Heaters: 1
8.8	Temperature Pressure Release Valve (TPR)/Discharge Pipe	•

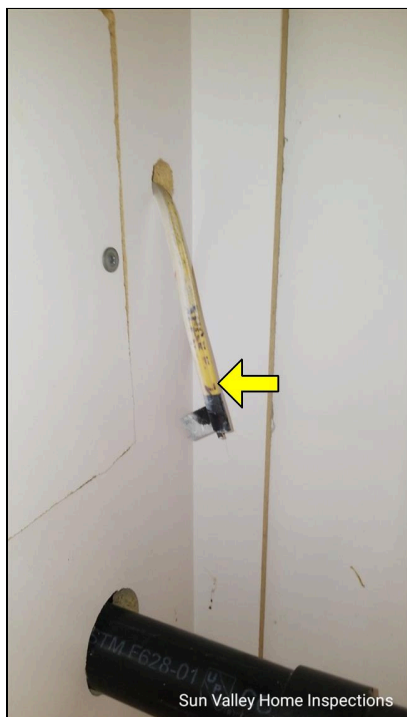
9.9 Electrical wires visible in the kitchen sink base cabinet terminated outside of a junction box. Although they were not energized at the time of the inspection, these wires may have the potential to become energized by a switch or circuit breaker.

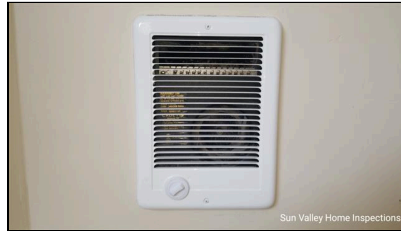
IN	NI	MD	RR	NP
10.0	Presence of Installed Heat Source in Each Livable Room	•				
10.1	Electric Baseboard and Electric Resistance Heaters	•
