METHOD HOME INSPECTIONS

## METHOD HOME INSPECTION

106 Village Way 10  
Sun Valley, ID 83353

Carissa Connelly  
AUGUST 5, 2024

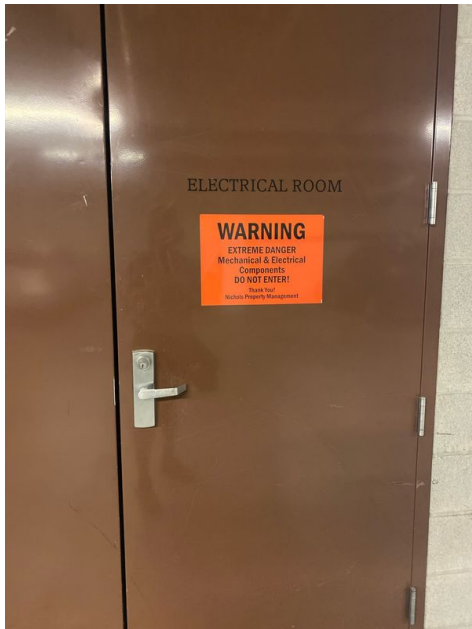
### LOCKED

The main electrical panel is locked behind a door controlled by the property management company and not able to be accessed.

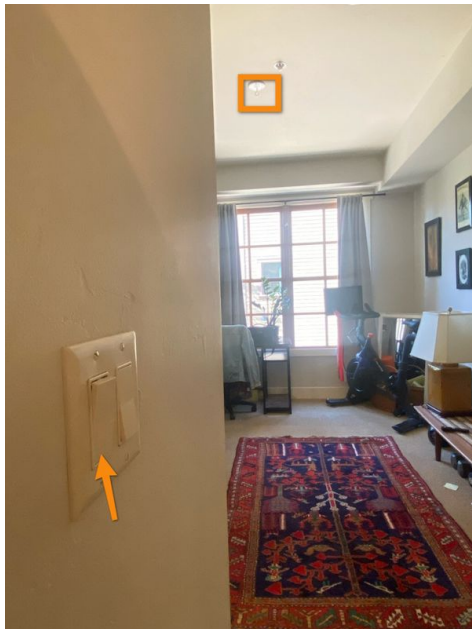
Bedroom 1

#### **NOT IDENTIFIED**

The inspector operates every accessible switch in the home. Multiple switches appeared to do nothing. The property owner stated these switches were for old lights that have been removed. Recommend having a qualified electrician install new lights or remove the switches if necessary.

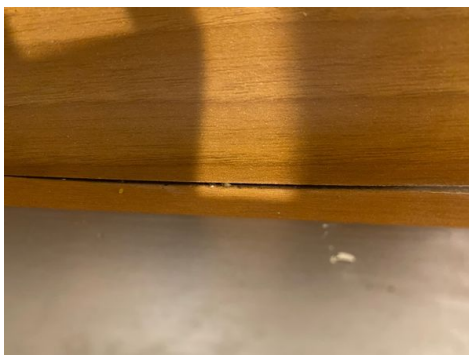
Kitchen

**NEED CAULK AT GAPS**

Gaps were present at the countertop in the kitchen. Water can penetrate this area and cause damage. Recommend installing caulk at gaps now and in the future, when necessary, to prevent water damage.

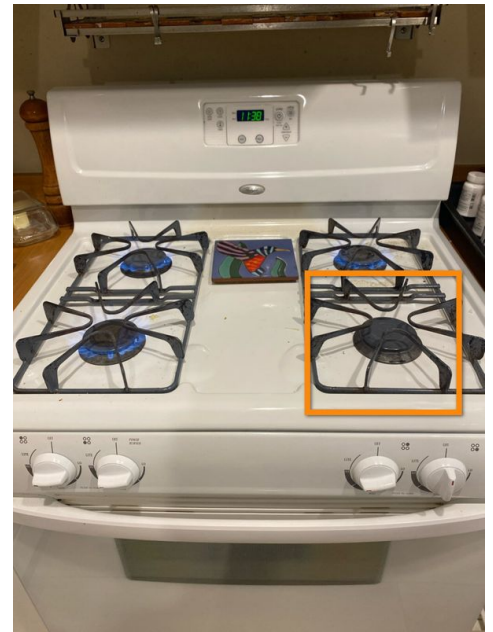
Kitchen

**INOPERABLE - COOKTOP**

1 cooktop *burner* was inoperable. The ports may need cleaning. Recommend that a qualified person repair as necessary.

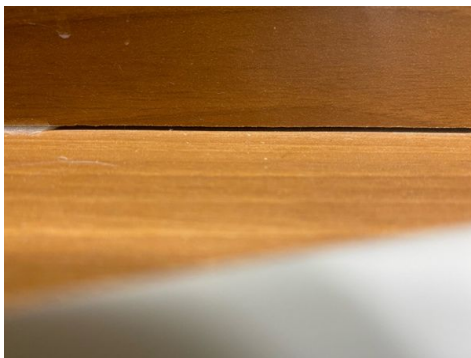
Master Bathroom

**MISSING CAULK**

Gaps were present at the countertops in the master bathroom. Water can penetrate these areas and cause damage. Recommend cleaning the area and installing caulk to prevent water damage.

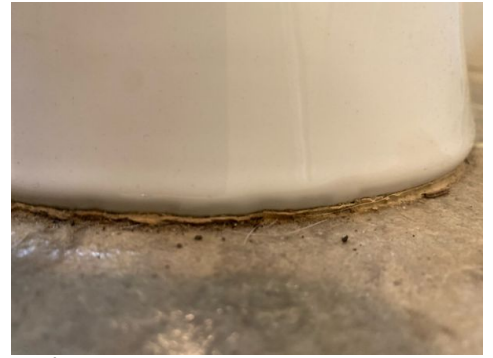
Bathroom 1

**NO OR BAD CAULK AT BASE**

Caulk around the base of the toilet was substandard or deteriorated. Modern standards require caulk to be installed around the entire toilet base where it meets the floor for sanitary reasons. Without it, soiled water can soak into flooring and sub-floor materials if the toilet overflows. Recommend that a qualified person caulk around toilet bases per standard building practices.

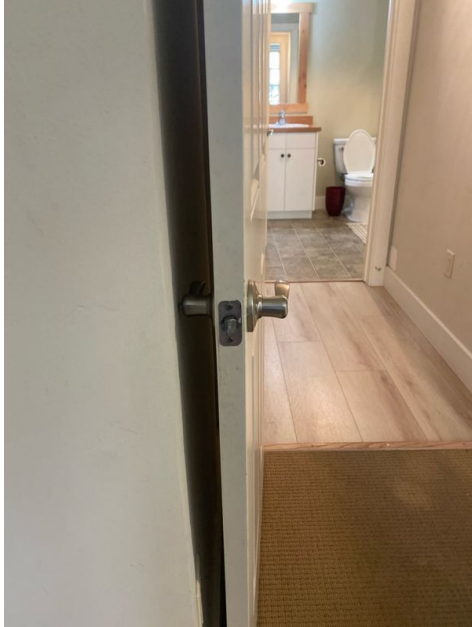
Bedroom 1

#### MISSING DOORSTOPS

Doorstops were missing or not working properly in multiple locations. Recommend installing doorstops to prevent wall damage.

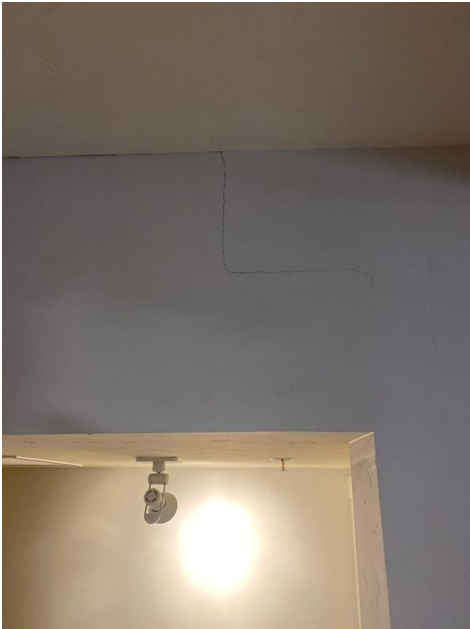
#### MINOR CRACK

One interior crack was present. This crack did not appear to be structural. Recommend monitoring in the future for change in appearance. The client may wish to seal and paint the crack for cosmetic purposes.

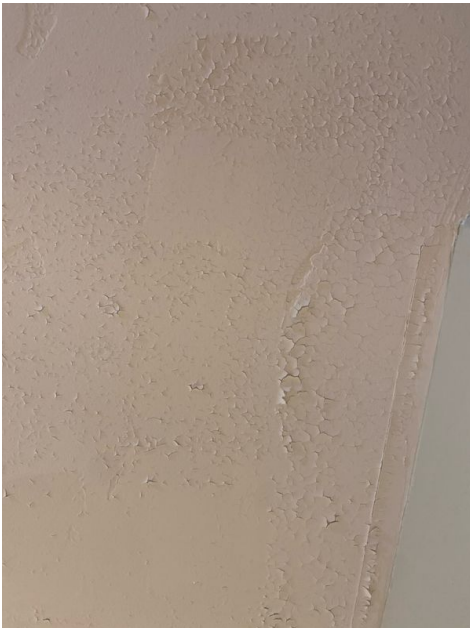
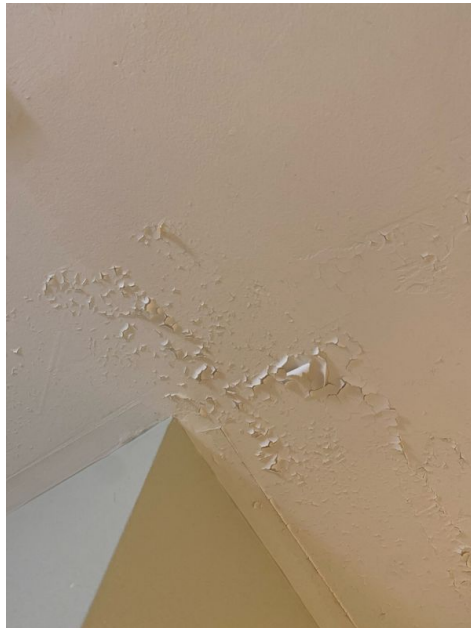
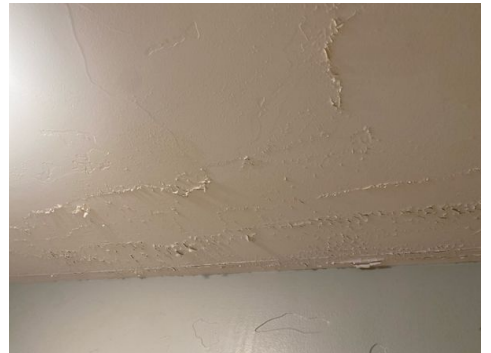
Bathroom 1

**DAMAGE TO PAINT AND WALL**

Damage to paint and wall appears to be due to moisture from the shower. Recommend cleaning the area and repainting to prevent further moisture damage.
