METHOD HOME INSPECTIONS

METHOD HOME INSPECTION

109 Angani Way 4
Sun Valley, ID 83353

Carissa Connelly
AUGUST 20, 2024

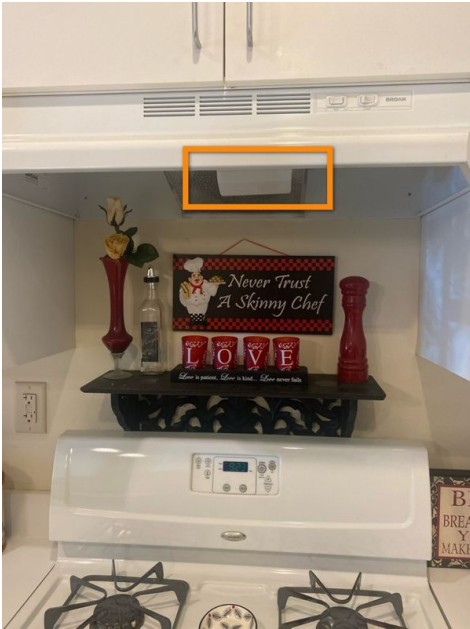
Oven

13.8.1 Range/Cooktop/Oven

INOPERABLE - OVEN LIGHT

The oven light was inoperable at the time of inspection. Recommend replacing bulbs and if necessary, a qualified appliance technician evaluate further.

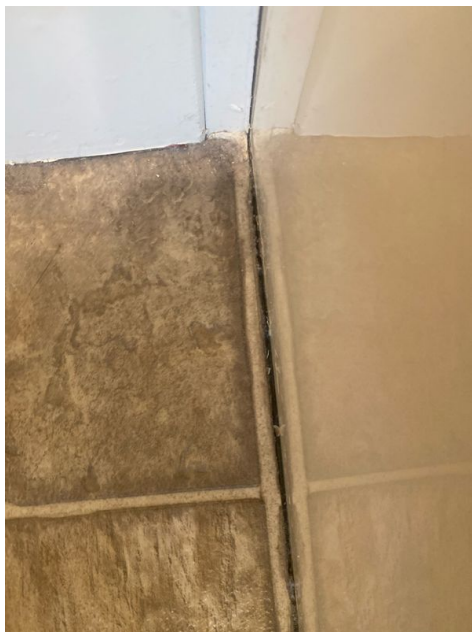
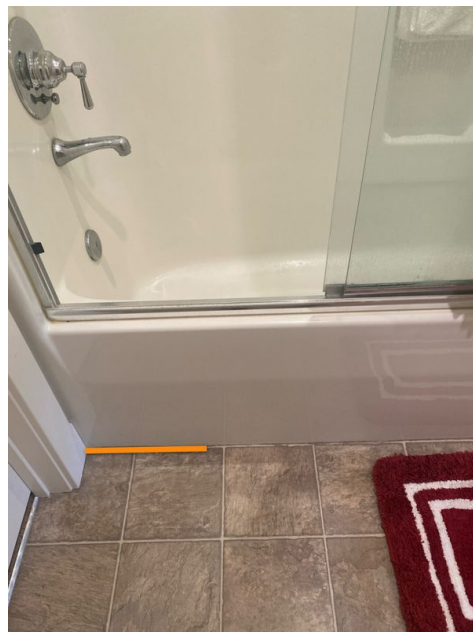
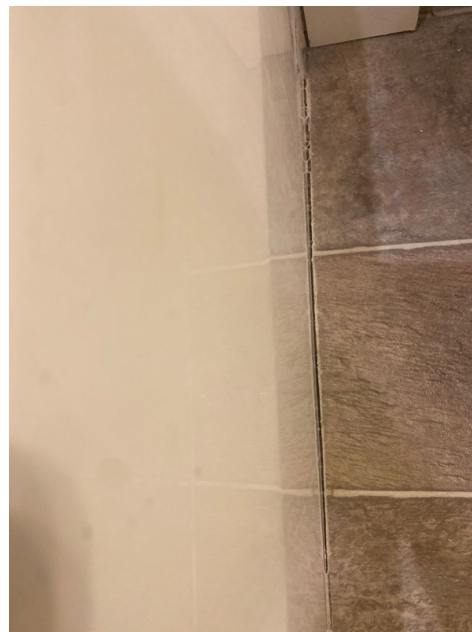
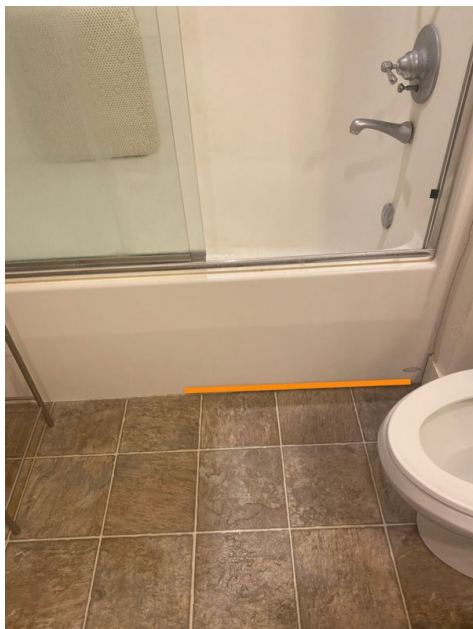
14.4.1 Floors

GAPS AT SEAMS

Gaps at seams in linoleum flooring were observed. Water can enter these areas and cause damage. Recommend a qualified person seal gaps where necessary to prevent lifting and water damage.

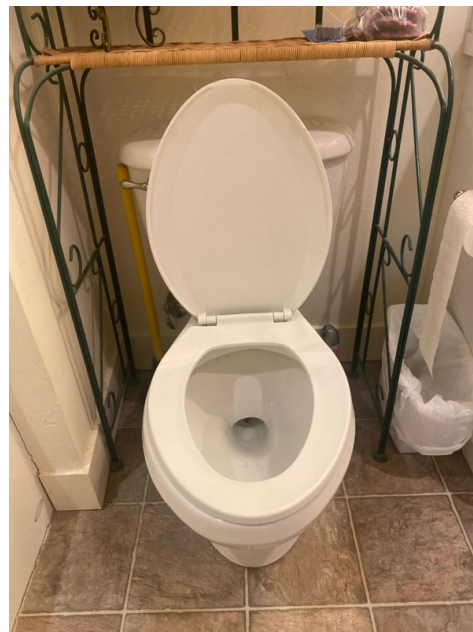
Bathroom 1

14.6.1 Toilets

LOOSE-REPAIR

The toilet was loose where it attached to the floor. Leaks can occur. Flooring, the sub-floor or areas below may get damaged. Sewer gases can enter living spaces. Recommend that a qualified contractor remove the toilet(s) for further evaluation and repair.

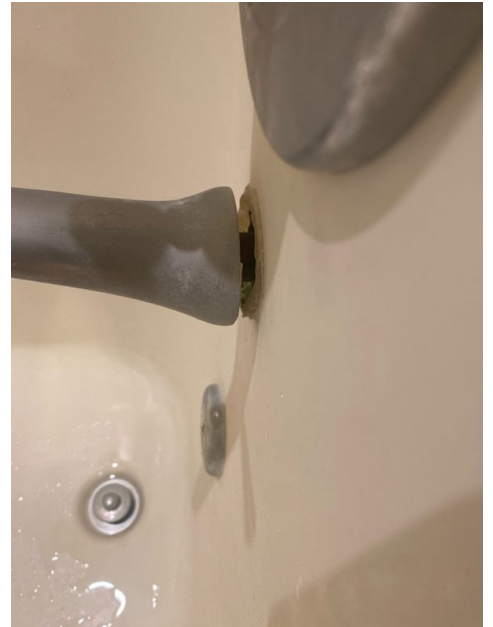
Bathroom 1

14.7.1 Bathtubs

GAP OR NO CAULK BEHIND SPOUT

Caulk was missing around the base of the bathtub spout, or there was a gap behind it. Water may enter the wall structure behind the bathtub. Recommend that a qualified person repair as necessary to eliminate the gap. For example, by installing or replacing caulk if the gap is small enough. For larger gaps, a shorter spout nipple or an escutcheon plate can be installed.

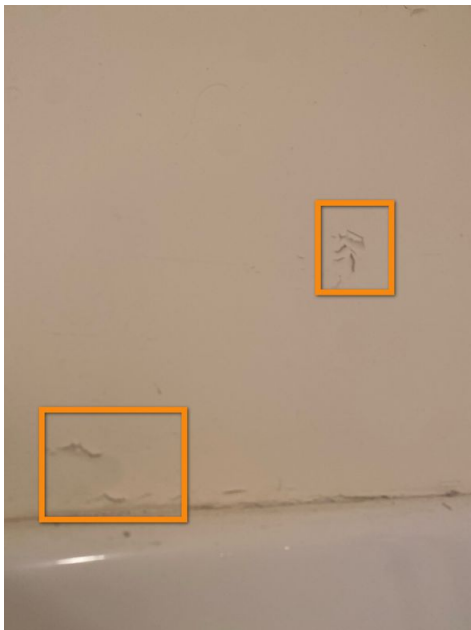
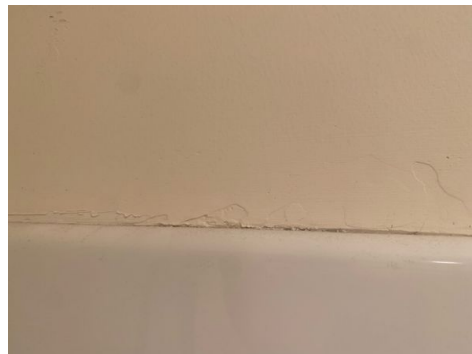
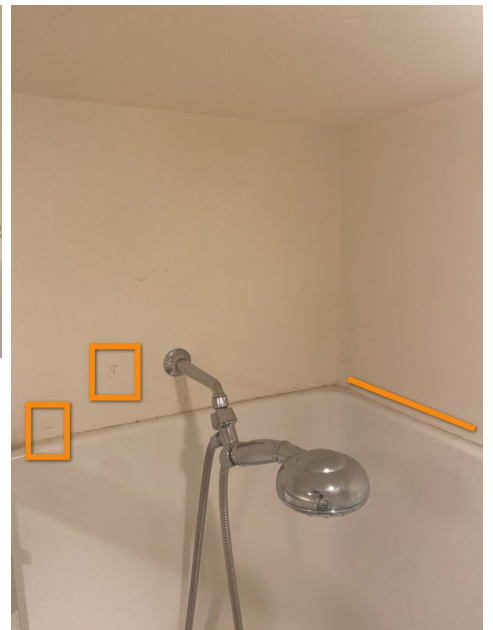
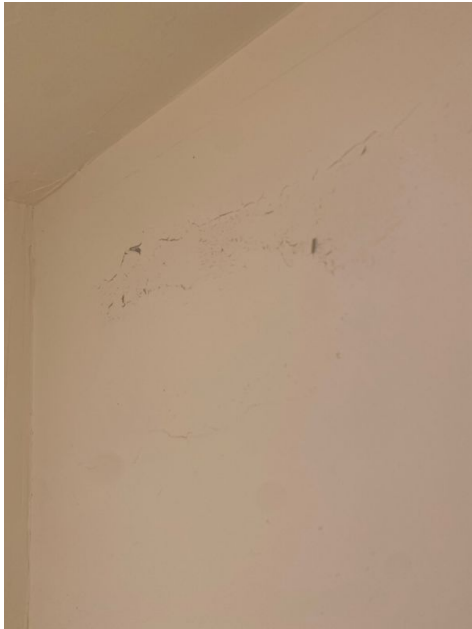
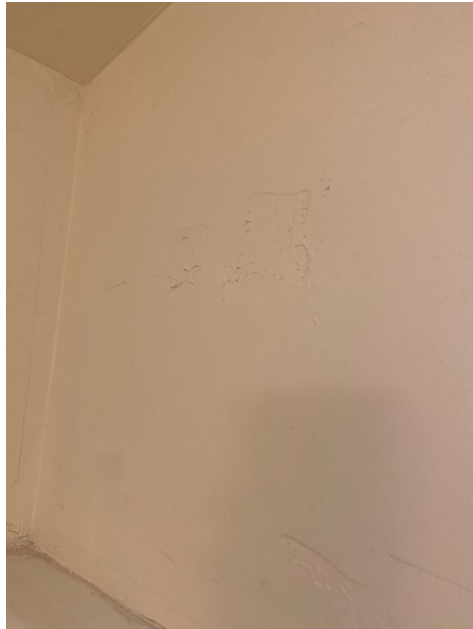
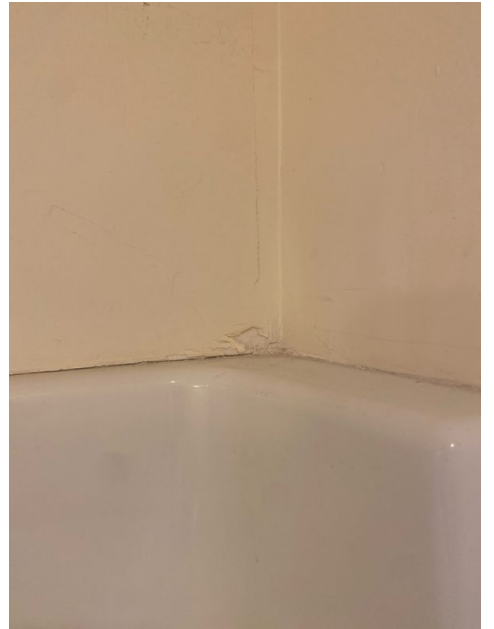
14.8.1 Showers

PEELING DRYWALL

Peeling drywall was observed in both bathrooms. The peeling drywall is likely due to moisture infiltration, which is a common issue in areas of high humidity like bathrooms. Recommend a qualified contractor evaluate and repair as necessary.

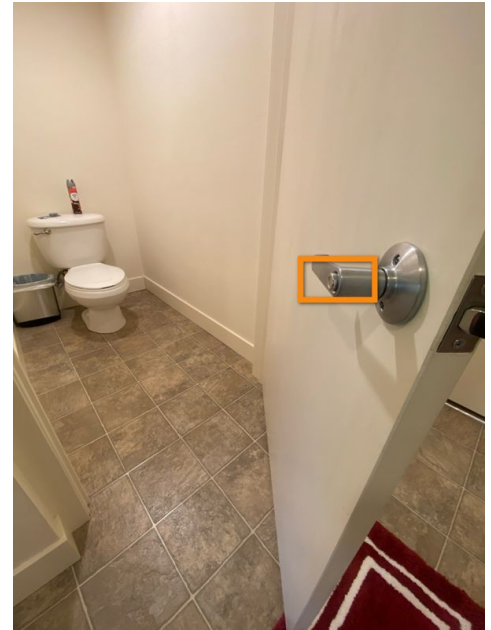
Master Bathroom

15.3.1 Interior Doors

LOCK INOPERABLE

The door to the bathroom would not lock. Recommend a qualified person repair if necessary.

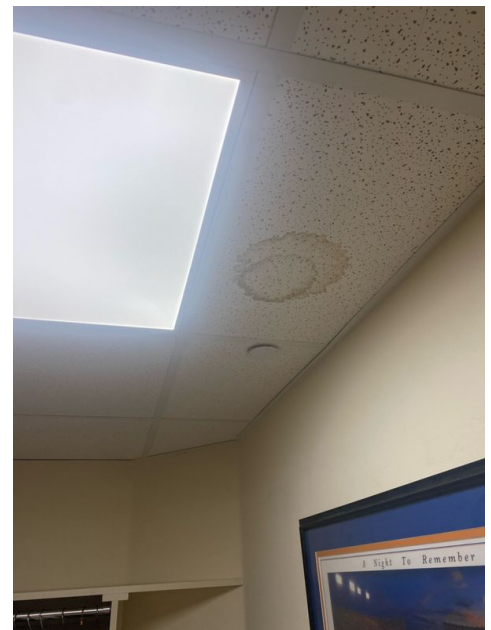
Bedroom 1 Closet

15.5.1 Walls, Ceilings and Fixtures

CEILING - STAIN, UNKNOWN IF ACTIVE LEAK

A stain was present in the closet in Bedroom 1. This appeared to be some kind of oil leaking from the unit above. The owner stated that the leak has grown in the last year. Recommend a qualified contractor evaluate and repair as necessary.

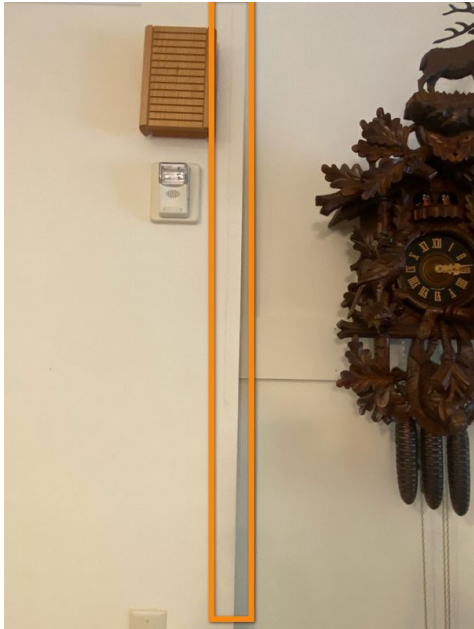
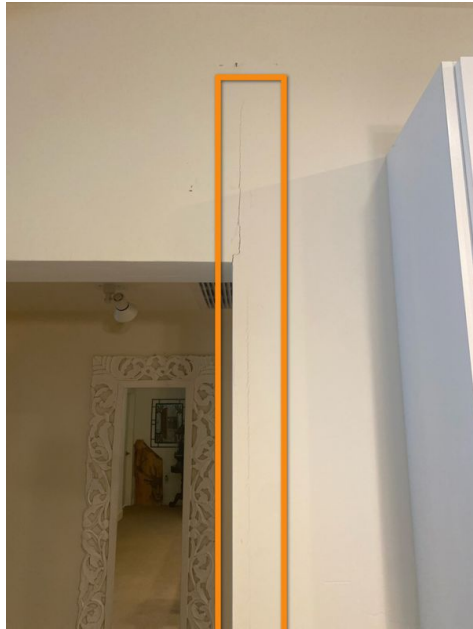
15.5.2 Walls, Ceilings and Fixtures

MINOR CRACKS, NAIL POPS

Multiple vertical cracks were observed inside the unit. These cracks did not appear to be structural. Recommend monitoring in the future and alerting the HOA with any major change in appearance.
