Inspection Report

225 Pinewood Ln #C16
Ketchum ID 83340

Sun Valley Home Inspections

Date: 11/10/2023	Time: 01:30 PM	Report ID: 20231110-225-Pinewood-Ln-C16
Property: 225 Pinewood Ln #C16 Ketchum ID 83340	Customer: Buck Drew	Real Estate Professional: Scott Mary

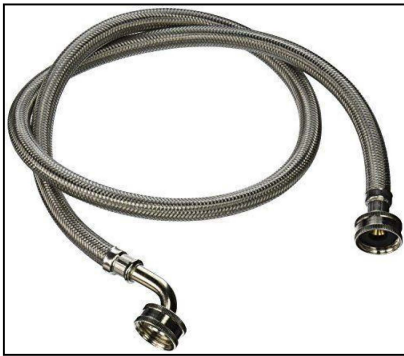
7.3 As a recommended upgrade, consider changing the existing washing machine water supply lines from the current rubber hoses to more durable and burst-resistant stainless steel braided hoses. This type of stainless steel hose has nearly double the PSI rating than those made from rubber and can help prevent

costly repairs due to a burst water hose.

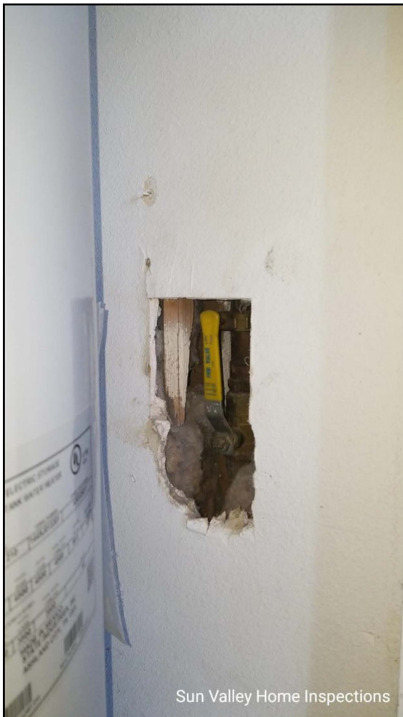
8.1 The main water supply shut-off valve is located in the 2nd bedroom closet next to the water heater.

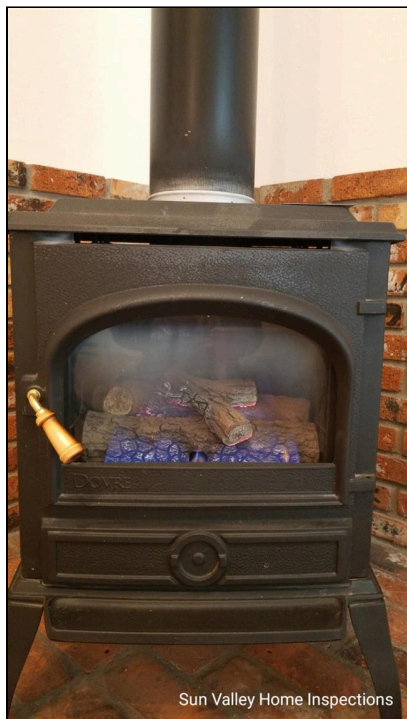
11.3 (1) The gas stove was activated and checked for installation and functional operation. No deficiencies were observed at the time of the inspection.

(2) The gas stove is operated with a switch mounted on the unit.
